WADD TECHNICAL NOTE 60-296

F-102 HIGH-ALTITUDE FLAMEOUTS IN AND AROUND THUNDERSTORMS

Project Nr 201A(1)

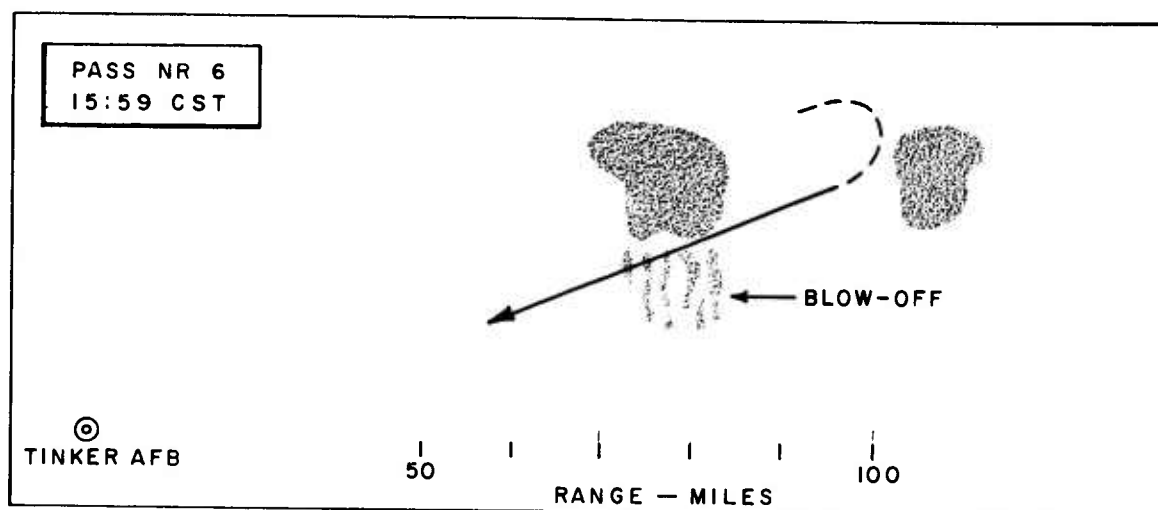
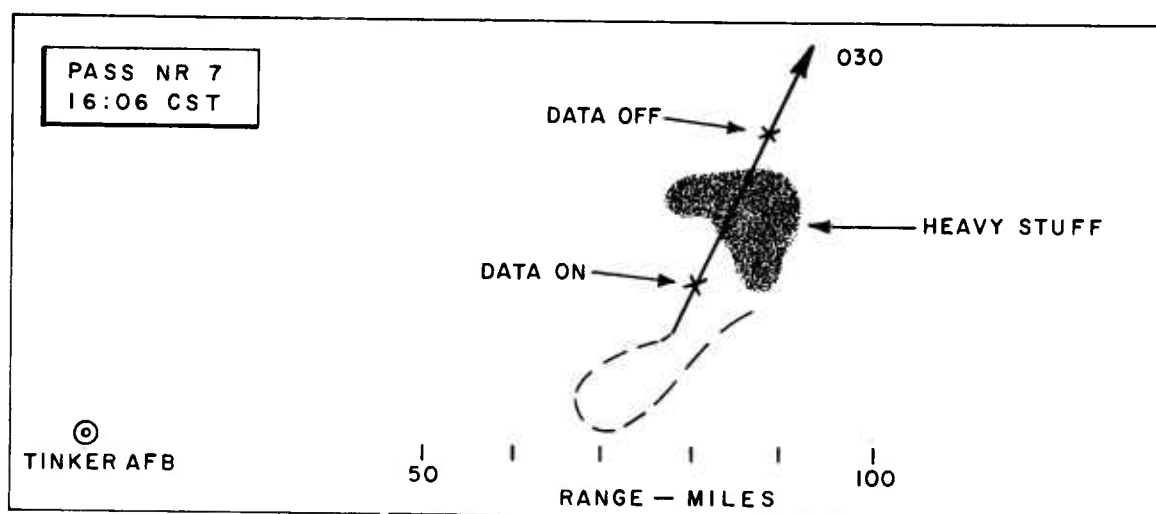
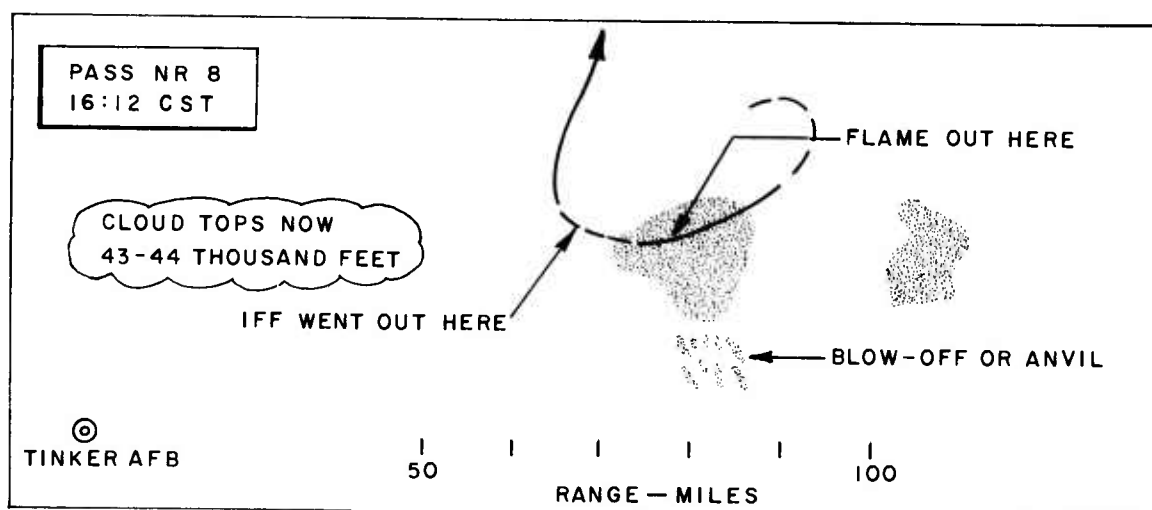
Figure B5. (Continued)

15:45 - Heading 210° at 38,000 feet. Experienced moderate turbulence and some moisture. After four stalls the airspeed dropped off 40 knots. RPM hung up at 78 percent for a while and then gradually increased to 79 percent. Fuel flow was stuck at 1500 PPH, EGT 400°, EPR 1.75. The aircraft broke out of the storm at 36,000 ft and engine recovery from this point was good. 23 stalls were experienced. They were not as strong as previous stalls but were spaced close together causing a rapid loss of EPR and RPM.
